Clyde River Landslide

Department of Geology, Perkins Hall, University of Vermont, Burlington, VT 05405

Abstract:

Jason Scott
Jason Bedard
Greg Van Gilder

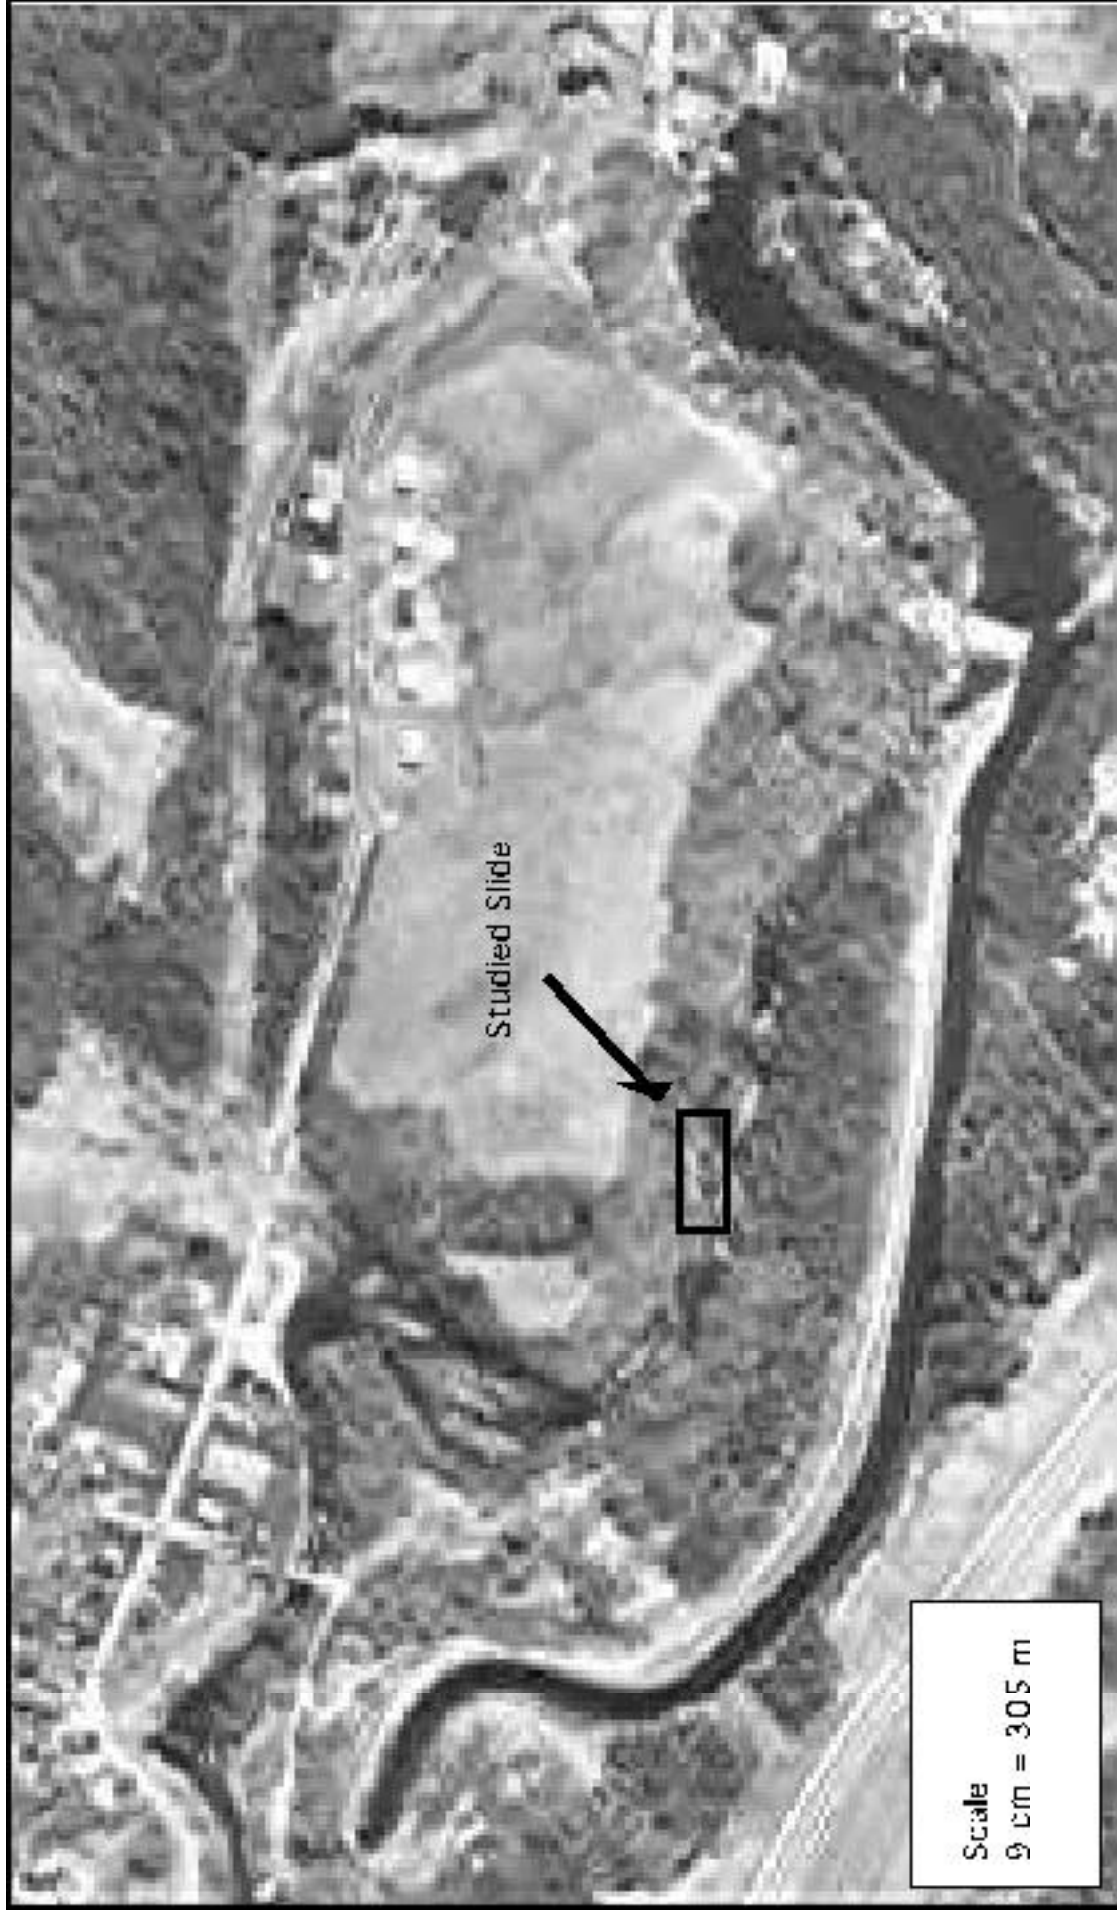
the top of the slide. Airphotos helped to determine the history of the slide. The 1963 and 1975 paper orthophotos showed that sliding had been taking place in the past (see figures 3 and 4). The 1987 printed photograph again revealed evidence of slope failure in the area of the slide studied. In the 1999 orthophotos the sliding was visible as well (see figure 2). Animal burrows were photographed (see figure 15), along with vegetation on the slide (see figure 14). Other observations include landslide scars next to the slide studied, along with river flow along the cut bank and the presence of undercutting. We also noted the stability of the layers. The clay and silt rhythmites were broken into two sections the upper redder section that yielded a strength around 1 and the lower grayier section yielded a strength around 2. The sand and silt rhythmites were visibly the weakest layer but could not be measured. Large cracks were visible that were easily pulled off the slide. Deposits on the sand and silt layer in the form of mud drippings down the 5 meter till deposit layer were visible. Also observed was the failed material forming an island in the middle of the Clyde River at the base of the landslide that helped to form a dam consisting of large woody debris (see figure 6).

Figure 3: This aerial photograph was taken in 1975. The area within the black box represents the studied landslide. This aerial photographs are important in studied the history and growth of the landsliding.

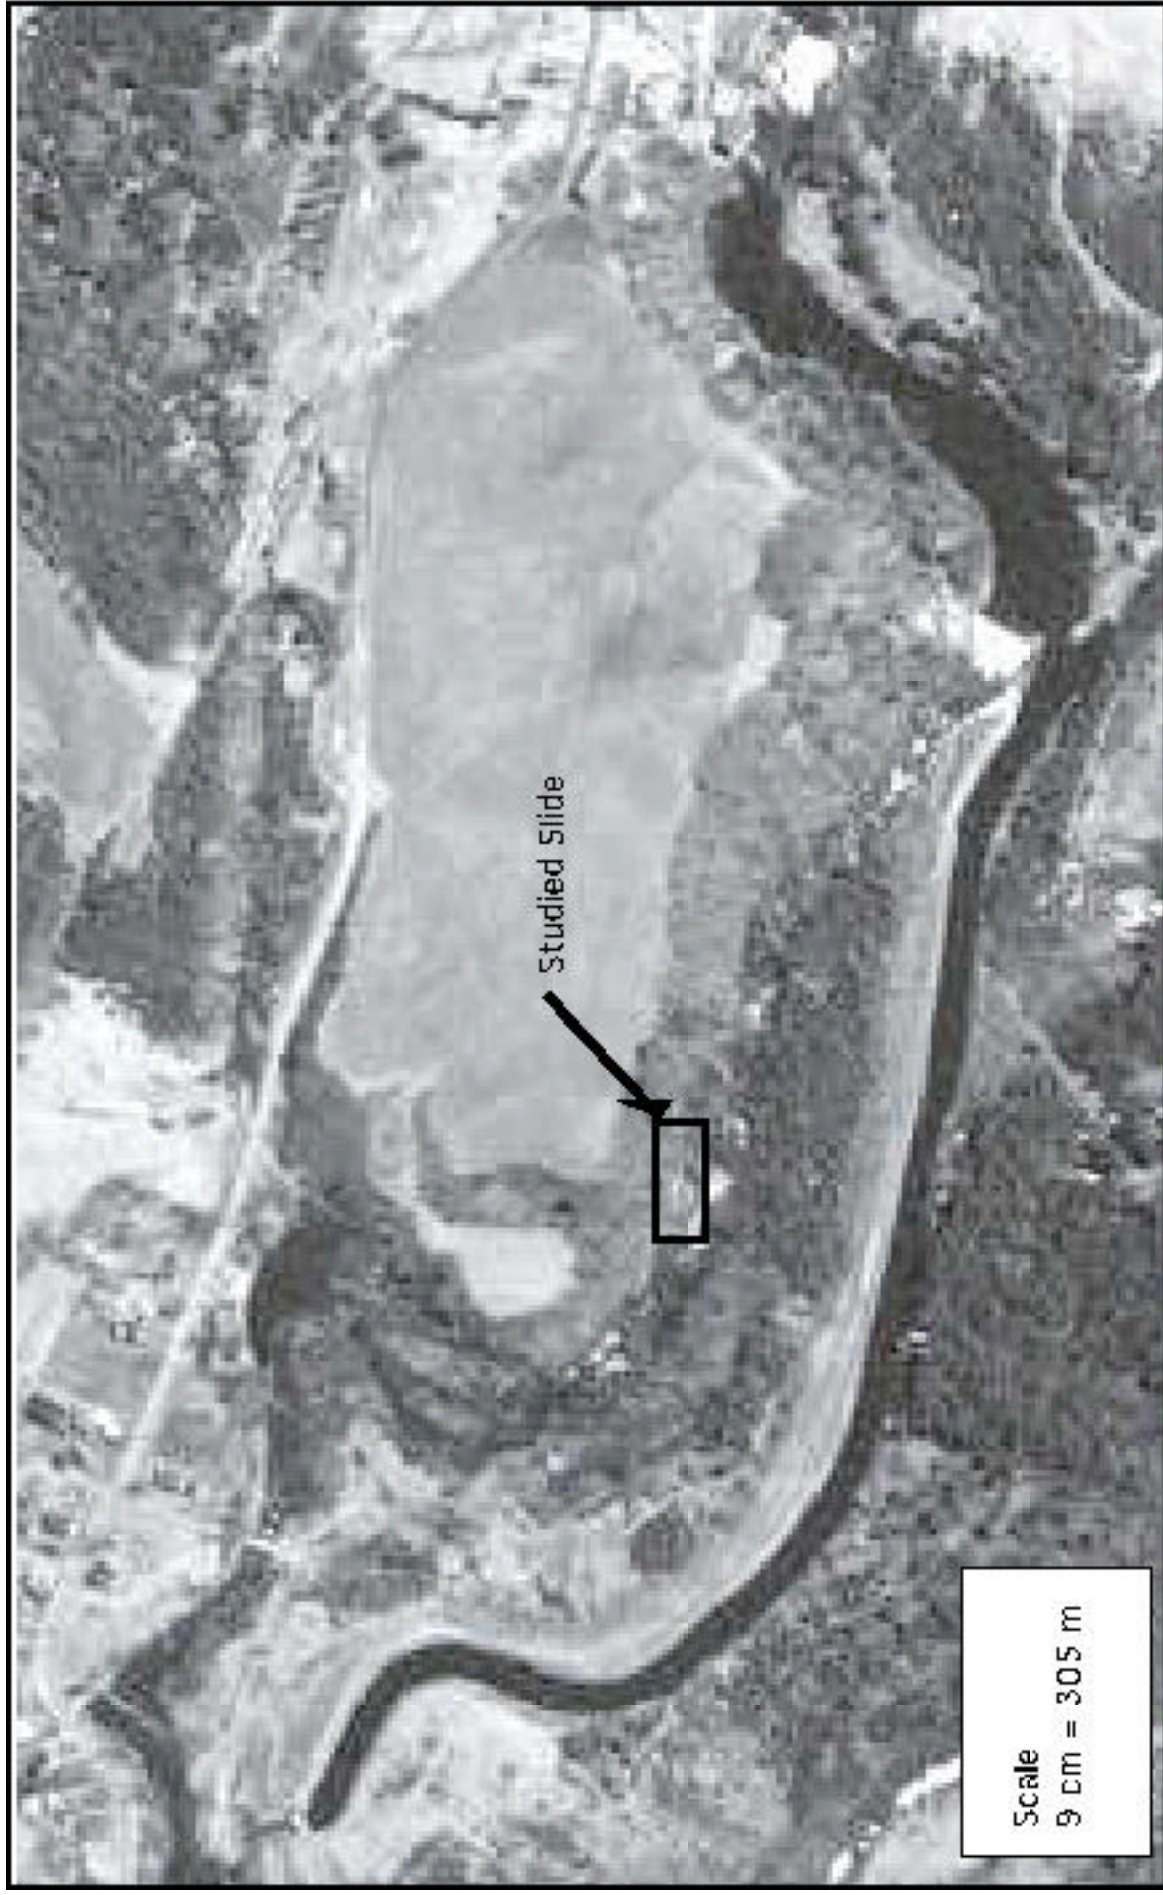
Figure 4: This aerial photograph was taken in 1963. The box highlights the studied landslide. From this photograph we can trace the history of the slide. From this data it can be concluded that the slide has existed since at least 1963.

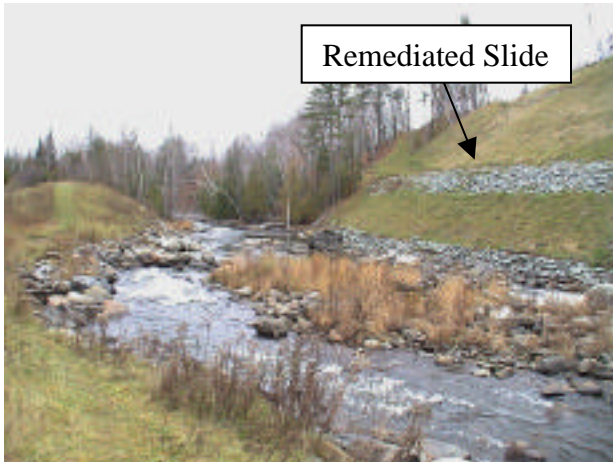
Figure 5

This is a view looking down the Clyde River above the slide. On the right is a remediated slide.

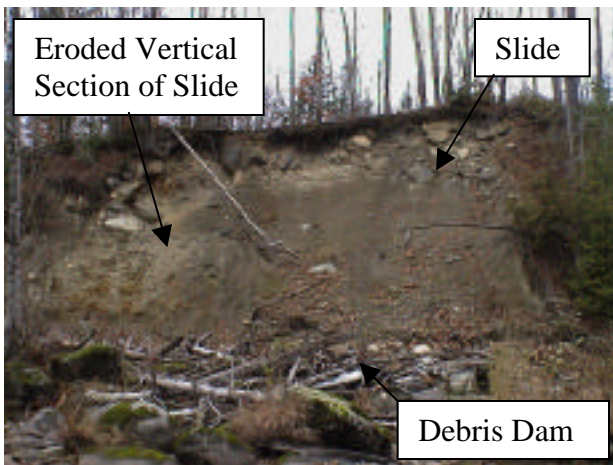
Figure 6

It was important to first distinguish the slide from an area of erosion on the left side of the landslide. We concluded that a slide occurred, and was later eroded by the river causing an area of vertical exposure (see figure 6). This area had been part of the original slide. Then, tape measurements were taken of the entire slide (see figure 17).

This is a view of the slide from across the river. The debris damn is visible in the foreground. The left side of the slide is the area of increased erosion with the exposed vertical stratigraphy.

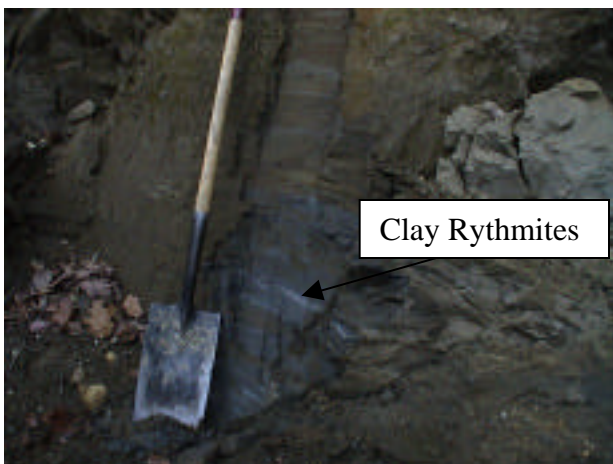
Figure 7

The initiation of landsliding was due to undercutting by the Clyde River. At the base of the slide the river has a higher velocity because the bank is on an outside bend. The erosion of the clay and silt layer prompted the gravel and sand layers to fail creating the landslide. Significant evidence for undercutting is directly related to the location of the landslide being on a cut bank. Flow data for the Clyde River for each month of the year from 1909 to 2000 was used to determine that undercutting most likely occurs in the

Clay and silt rythmites deposited by a glacial lake. This layer was undercut by the river. This removal initiated the first slide

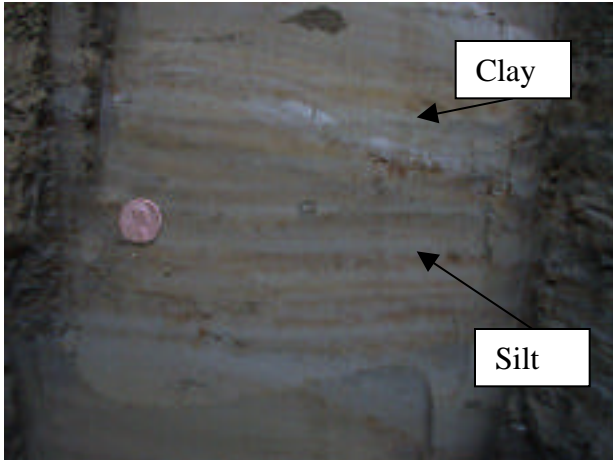
Figure 8

The redder clay and silt rythmites above the grayier clay and silts.

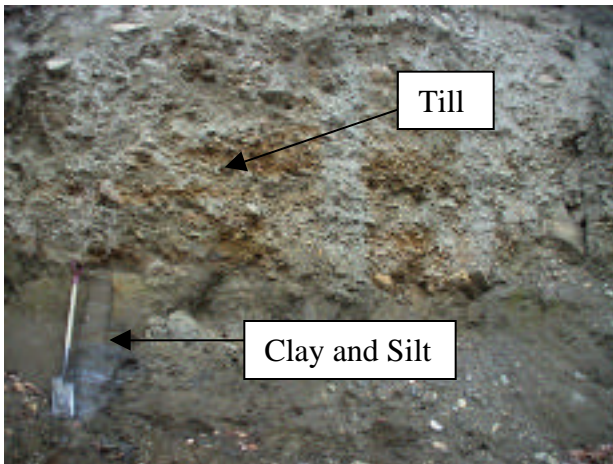
Figure 9

The section of the landslide next to the debris dam, which has been removed due to erosion, is an extreme case of the instability of the sediments within the slope (see figure 9). This section of total failure was due to the damming of the left side of the river channel. The dam caused the water to flow around it causing heavy erosion of the slide. This left section had the clay and silt rythmite section removed causing the layers above to fail (see figure 7). The failed material was completely removed except for large boulders and cobbles that could not be transported by the river.

This is the exposed vertical section of the slide due to heavy erosion. The clay and silt rythmites with till deposits above (sands, pebbles, and cobbles). This till is a result of the re-advancement of glaciers.

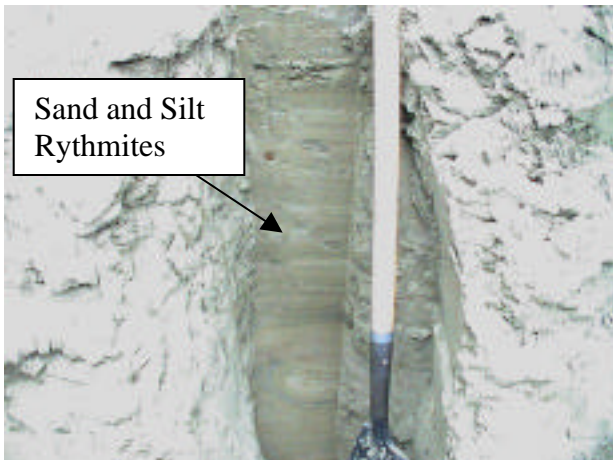
Figure 10

The layer that is most responsible for current sliding is the sand and silt layer. The loose sands and silts are easily carried away by water (rain). They are very fine grained and it does not take much energy to move them. Evidence for the erosion of the sand layer (via water) are the mud droplets. These droplets are small mud deposits (muddy water droplets that trickled down) on the till below. This is evidence that the sand and silt layer is the most susceptible layer to erosion. Also, the sand and silt rhythmic layer at the top of the slide is approaching an angle of 90 degrees. This top layer of sand and silt rhythmites is highly unstable due to the lack of cohesiveness of the sands. When the sand and silt layer is disturbed gravity pulls the sands away from the wall causing the layer to fail. The material then falls onto the slope, increasing the angle, and the potential for further failure. Boulders and sediments above the sand and silt layer also fall because

Fine sand and silt beds above the till deposits. This layer is responsible for the continual failure of the slope. It is very dry and cracks are visible across the entire layer.

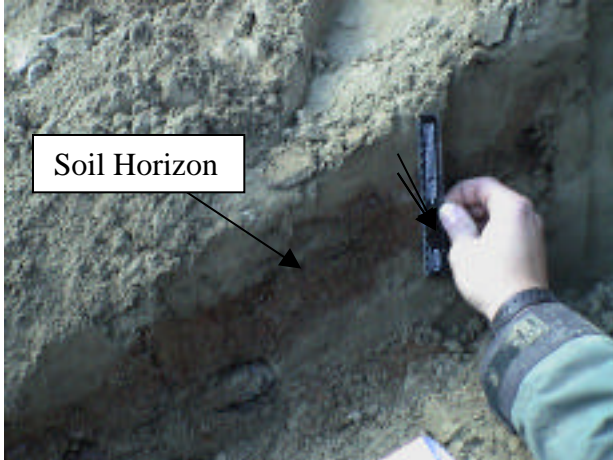
Figure 11

A soil horizon between the fine sands and silts. The soil represents a period of stability, the sands and silts failed again burring the soil. The soil is at an angle of 32° and the slope is at an angle of 42° . Stability lies somewhere in between.

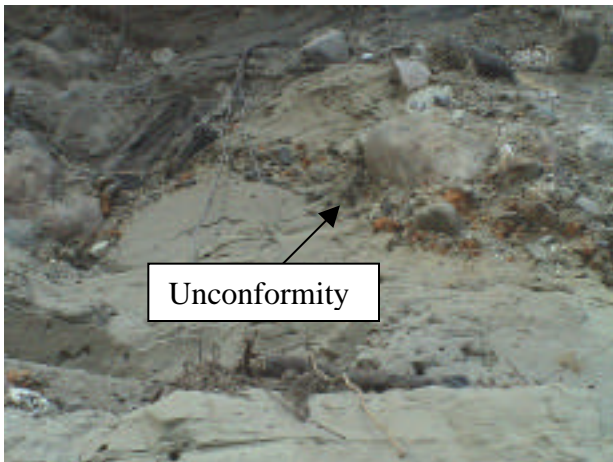
Figure 12

An unconformity exists between the fine sands and silts and the large till deposit. The unconformity is a layer of sand and pebbles.

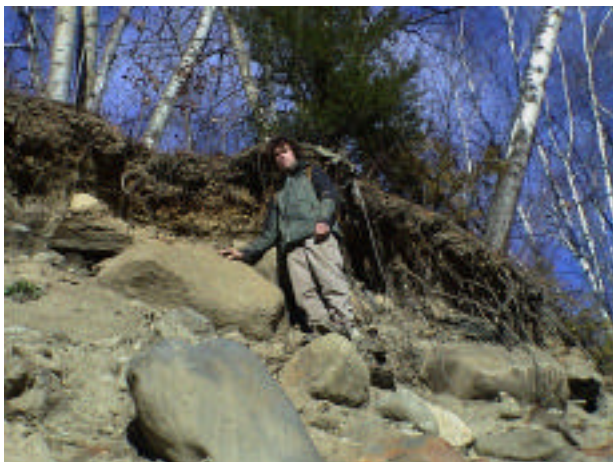
Figure 13

Greg standing at the top of the slide with large boulders deposited by high energy fluvial deposits..

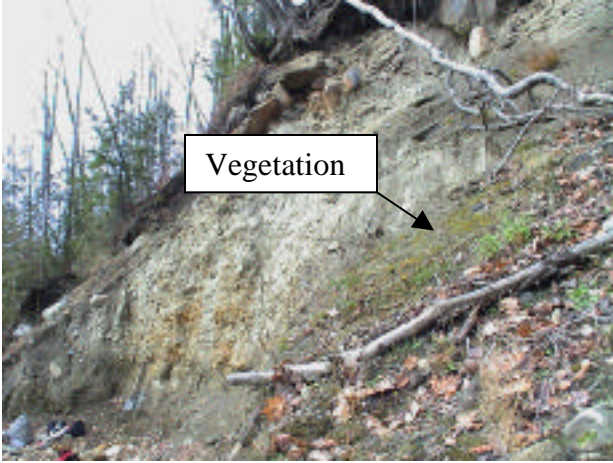
Figure 14

Vegetation is visible on the slide. This is useful for dating the slide. The young vegetation represents the short period of time for vegetation to grow between slide events.

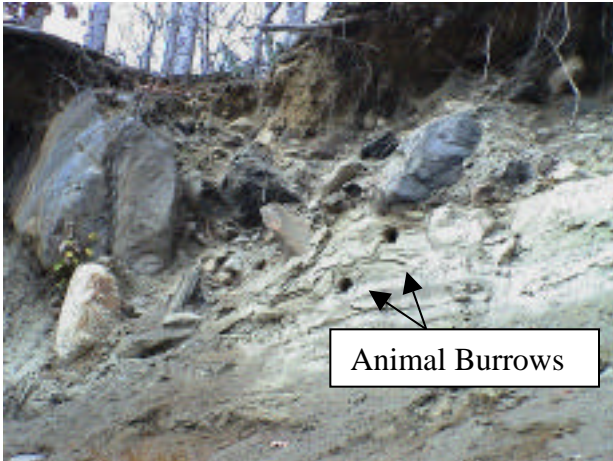
Figure 15

Animal burrows are visible at the top of the slide helping with dating. They are helpful because we know the slide hasn't failed since the burrows were dug.

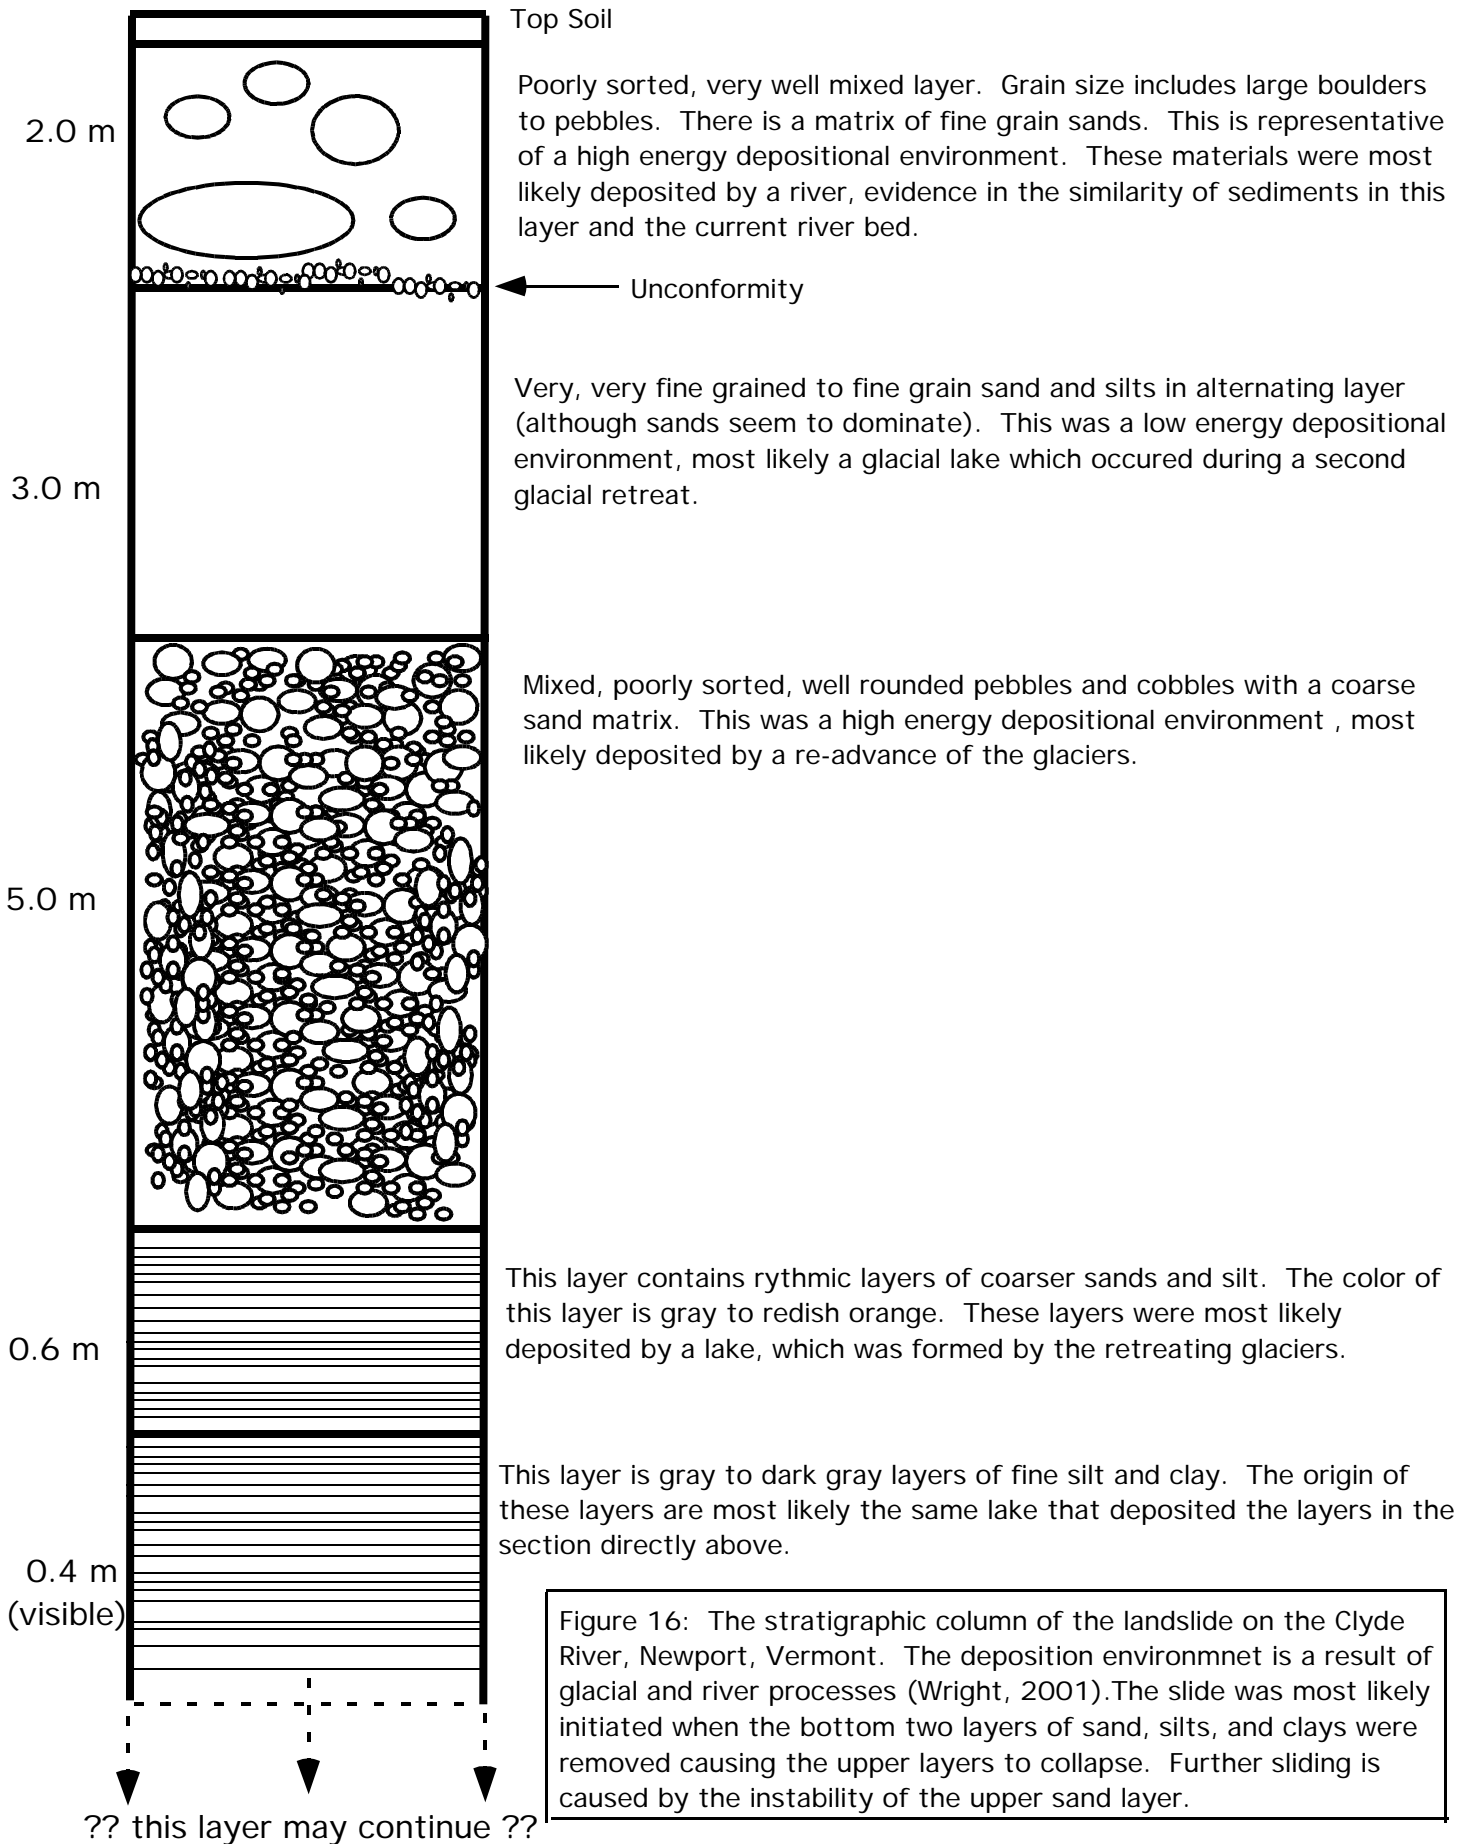
Stratigraphic Column of Sediments

Figure 16: The stratigraphic column of the landslide on the Clyde River, Newport, Vermont. The deposition environment is a result of glacial and river processes (Wright, 2001). The slide was most likely initiated when the bottom two layers of sand, silts, and clays were removed causing the upper layers to collapse. Further sliding is caused by the instability of the upper sand layer.

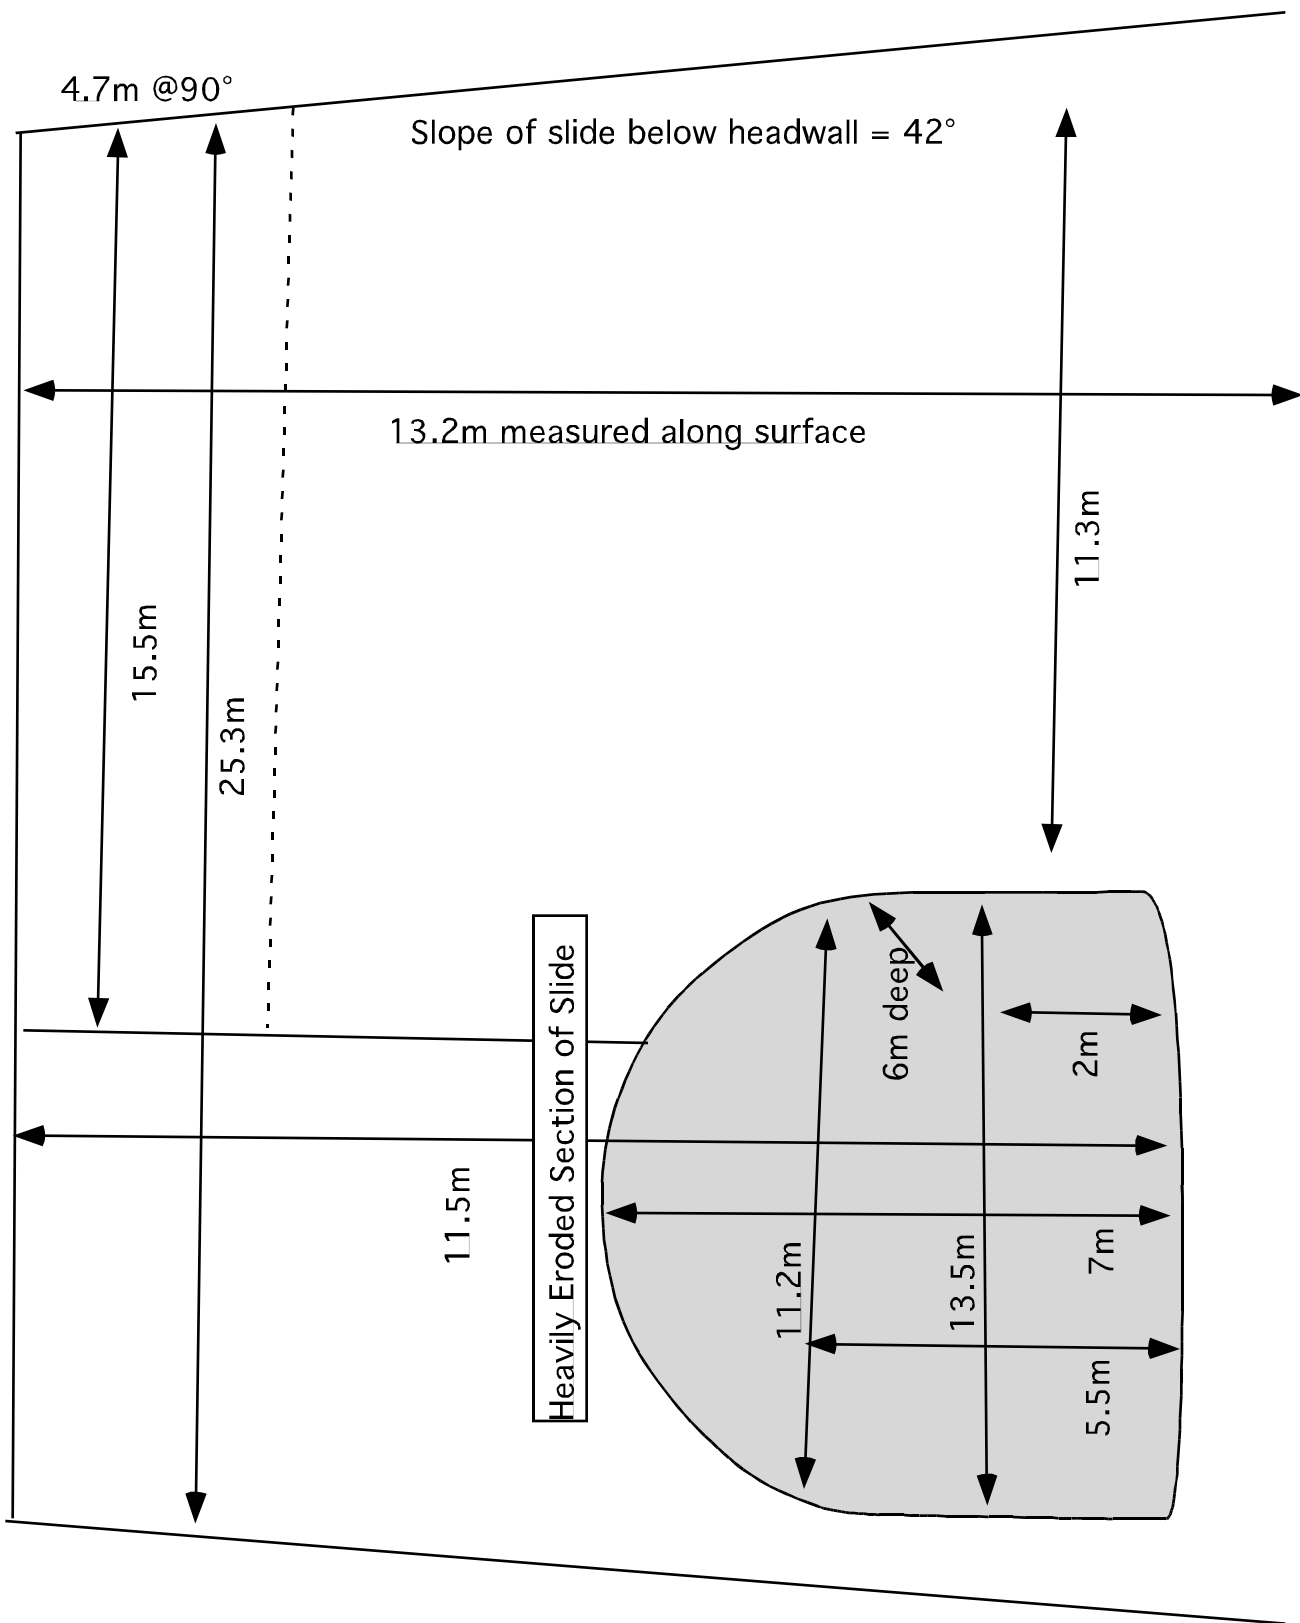
Dimensions of The Clyde River Landslide

The volume of material that has failed was calculated using the tape and stadia rod and bubble level measurements, 350m³ of material slid and slumped. The slope of the lower sub-vertical section of the slide was roughly 42 degrees. Strike and dip were taken of a soil layer found between the fine sand and silt layer and a layer of failed material, its slope is 32 degrees (see figure 11). The stratigraphy of the landslide consisted of four primary layers (see figure 16), on the bottom a 1m clay and silt rythmite layer (see figures 7 and 8), then a 5m layer of till deposits consisting of sands, pebbles, and cobbles (see figure 9). On top of that layer is a 3 meter layer of fine sand and silt rythmites (see figure 10), with a 2 meter layer of fluvial deposits with boulders up to 1.5 meters wide deposited above (see figures 12 and 13). A small topsoil layer is present at

Figure 17: This figure shows the dimensions of the landslide being studied on the Clyde River, Vermont. The calculated slope is 42°. The calculated volume of the slide is 350 m³. This offers a bird's-eye-view. The gray area represents the section of the slide that was further eroded by stream erosion..
