Runoff from paved and unpaved parking lots at the Spruce Peak parking area Stowe Mountain Resort, Stowe, Vermont.

Marianne Muth, and Lelia Pascale

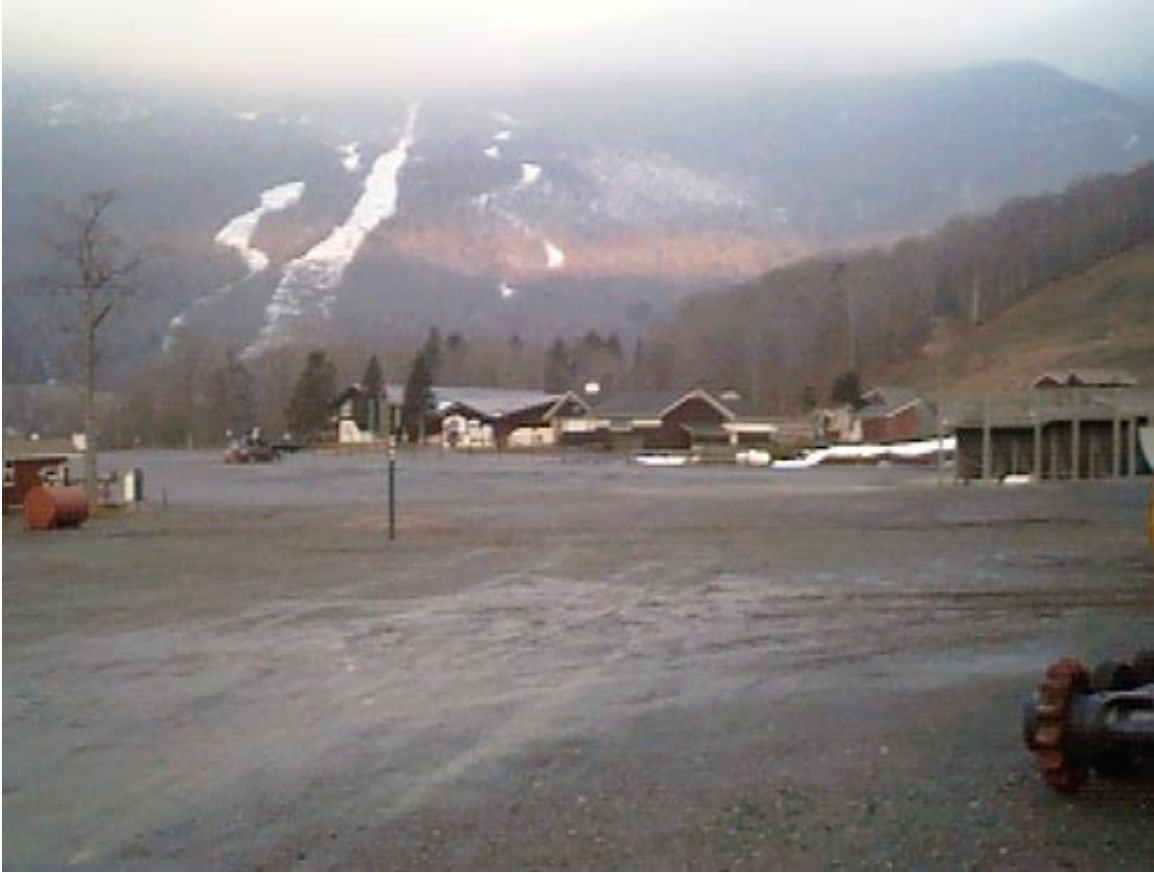
Figure 4: The two parking lots at Spruce Peak, Stowe Mountain Resort. The unpaved lot is in the foreground, and the paved lot is in the background. The boundary between the two lots is roughly marked by the pole to the left of the middle of the picture.

The watersheds of Ranch Brook and West Branch are located in Stowe, Vermont (Fig. 1 and 2). The sites studied in this paper are located at the Spruce Peak parking lots off Rt. 108 (Fig. 3), and are part of the West Branch Watershed. The Spruce Peak parking lots include one lot that is paved with asphalt and another that is dirt (Fig. 4). Above these areas are two different streams that enter culverts. The streams are diverted under the paved or unpaved areas, respectively (Fig. 3). The stream above the paved parking lot, designated paved upper (PU), runs down a steep slope in a line of trees between the Meadows ski trail and the Alpine Slide, and the other stream (unpaved upper (UU), Fig. 5a) runs under the unpaved lot and meanders down a steep wooded area. The streams surface below their respective lots separately (designated paved lower (PL), and unpaved lower (UL) Fig. 5b), and eventually merge about two meters downstream from the end of each culvert.

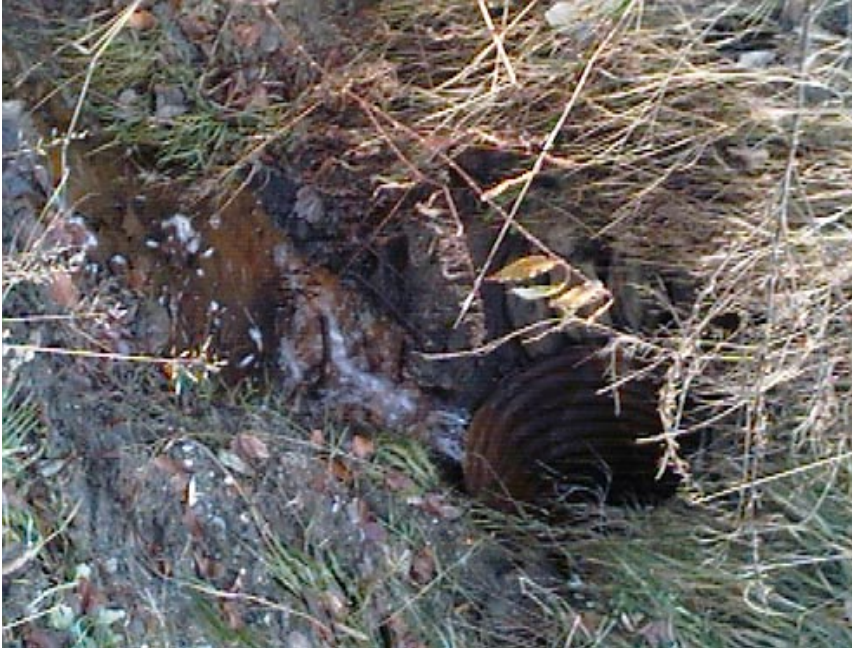
Figure 5a: The lower sample site for the Unpaved lot.

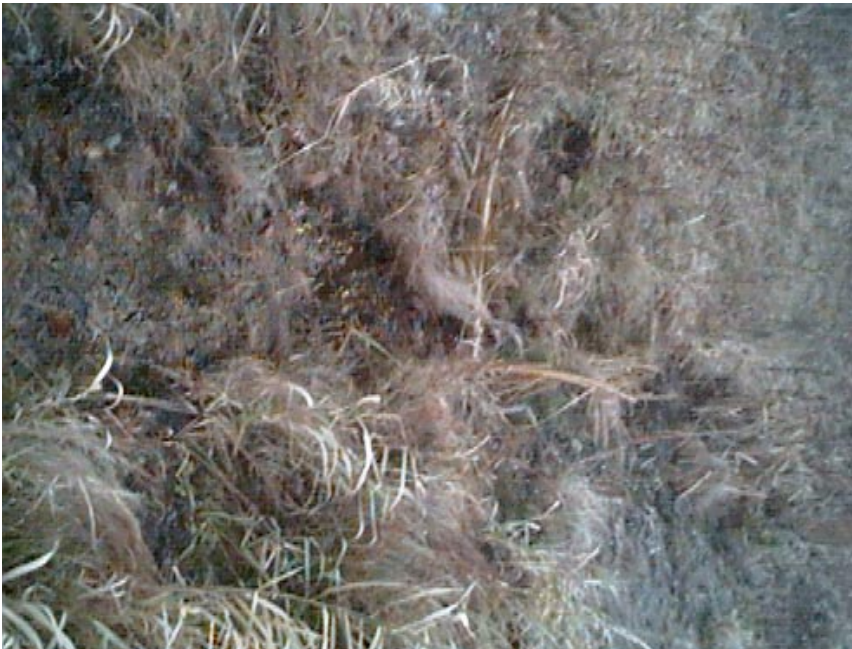
Figure 5b: The upper site for the Unpaved lot. The stream is difficult to see due to the poor resolution of the photograph.

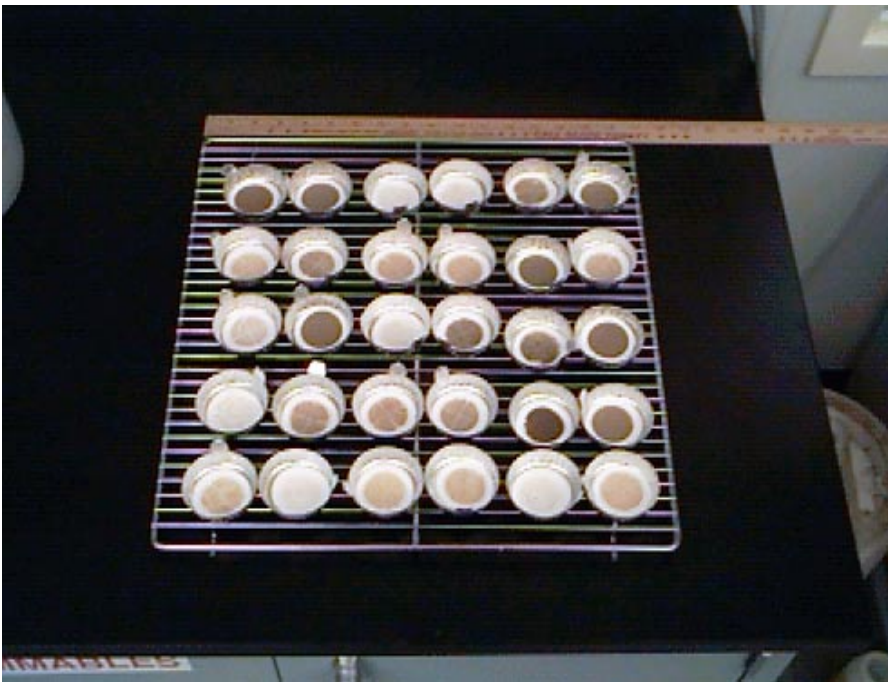
Figure 7: All 30 samples, after they have been filtered. Note the large variance in color; this is actually a large difference in sediment amounts for each filter, which represents one sample bottle, with the exception of two bottles, which are represented by two filters each.

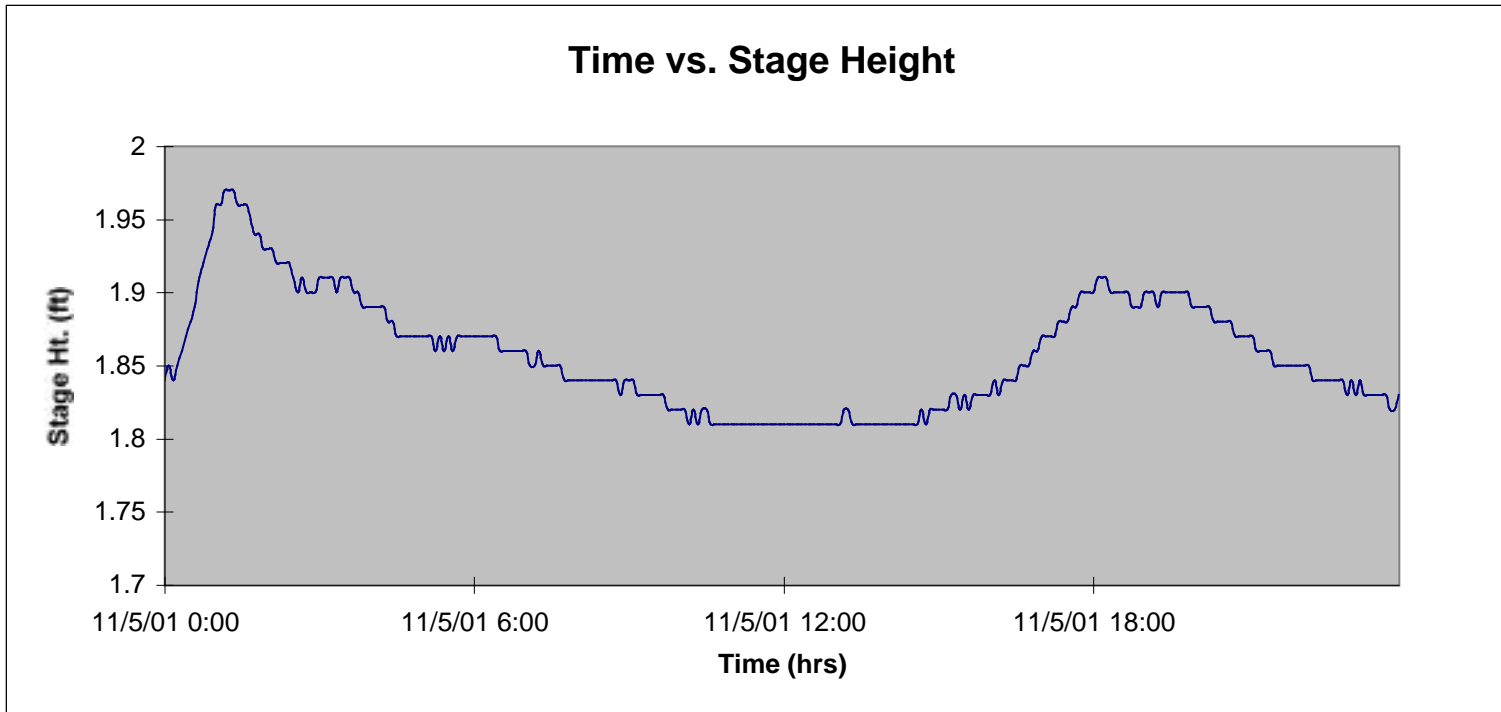
Figure 10: The Stage Height as measured by the USGS over the day that our samples were collected. This graph can be used in conjunction with Figure 9 to see the time of peak stream flow.

After analyzing [TSS] and comparing it to the stream flow data for the West Branch stream, we noticed a correlation between the amount of water flowing through the stream and the [TSS] (Figs. 9 + 10). As the flow of water increased, so did the [TSS]. These data support our hypothesis that stream flow would correlate with sediment load. The discrepancy in time, about one hour, could be due to the fact that the flow data was taken downstream from the sites of our samples, where the stream into which our streams empty (West Branch) is much larger. The flow data could therefore not be particularly significant for our streams, which were uphill from that collection site. It would be plausible that because precipitation moves from the top of the hill to the bottom, we would see an increase in flow (and thus sediment) higher up on the mountain before we would see that increase in flow downstream.
