**UVM DELEHANTY GEOLOGY LAB
AIR-HANDLER PERFORMANCE TESTING
FINAL REPORT**

CLEANROOM CERTIFICATION REPORT

Project: #060508
UVM Delehanty Geology Lab
Air-Handler Performance Testing
Final Report
Report Date: July 03, 2008
Project Manager/NEBB CPT Supervisor:
Jeffrey J. Jimmo

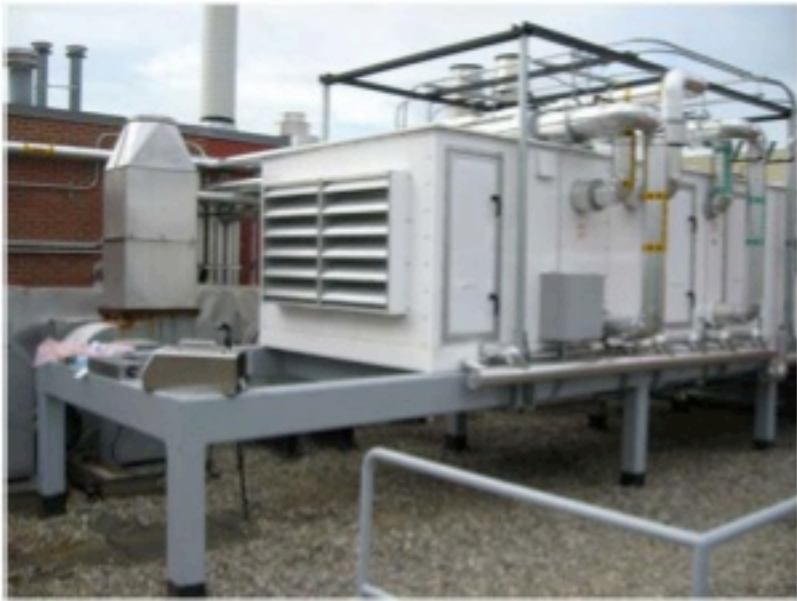
Roof Top "CleanPaK"
Air Handler

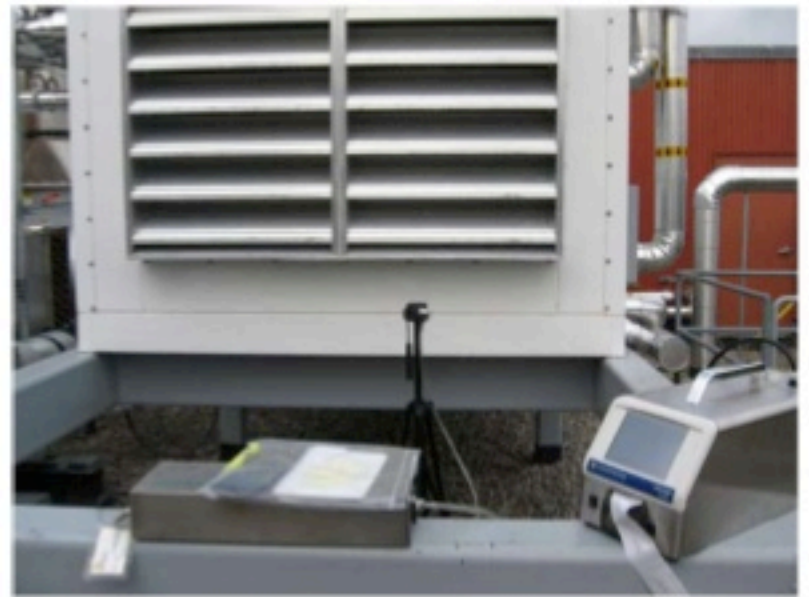
Roof Top AHU
Location #2 (right
side of intake)

Roof Top AHU Location #2 (Right side of intake)

Sample	Date	Time	Particle Sizes Micrometers							
			0.1	0.15	0.2	0.25	0.3	0.5	1	5
1	6/19/2008	8:18:12	114187	81749	44958	13414	8569	392	53	1
2	6/19/2008	8:19:51	113982	81026	44296	13002	8146	339	33	0
3	6/19/2008	8:21:02	112811	79411	43180	12420	7691	321	35	0
4	6/19/2008	8:22:13	110568	77582	42305	12434	7903	375	50	0
5	6/19/2008	8:23:27	110087	77042	41963	12364	7722	309	29	0
6	6/19/2008	8:24:43	109001	78151	44077	13653	8587	388	78	0
Average Count			111773	79160	38463	12881	8103	354	46	0
Normalized 100:1 dilution count			11177267	7916017	3846317	1288117	810300	35400	4633	17
Average Normalized 100:1 dilution count			11505008	8296683	4342492	1385467	874158	39942	5058	108

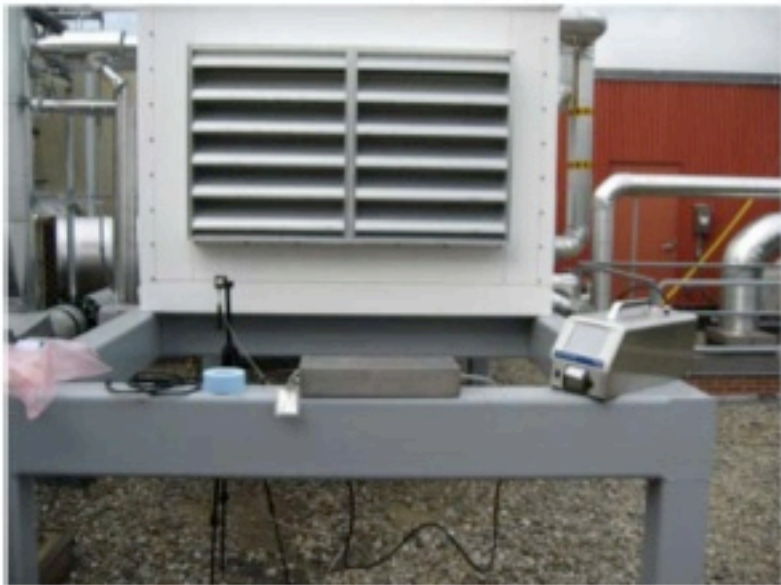
Roof Top AHU
Location #1 (Left
side of intake)

Larger particle sizes skewed
Outside conditions were windy which affected particle populations

Roof Top AHU Location #1 (Left side of intake)

Sample	Date	Time	Particle Sizes Micrometers							
			0.1	0.15	0.2	0.25	0.3	0.5	1	5
1	6/19/2008	8:10:23	120668	90756	51647	16224	10148	504	62	8
2	6/19/2008	8:11:37	120439	90412	51262	16093	10226	456	61	1
3	6/19/2008	8:12:53	118663	87159	48424	14888	9436	470	64	0
4	6/19/2008	8:14:07	117649	85037	46856	13982	8955	414	52	1
5	6/19/2008	8:15:20	117300	84336	46224	13982	8806	429	43	0
6	6/19/2008	8:16:33	115246	82941	45907	13800	8710	396	47	2
Average Count			118328	86774	48387	14828	9380	445	55	2
Normalized 100:1 dilution count			11832750	8677350	4838667	1482817	938017	44483	5483	200

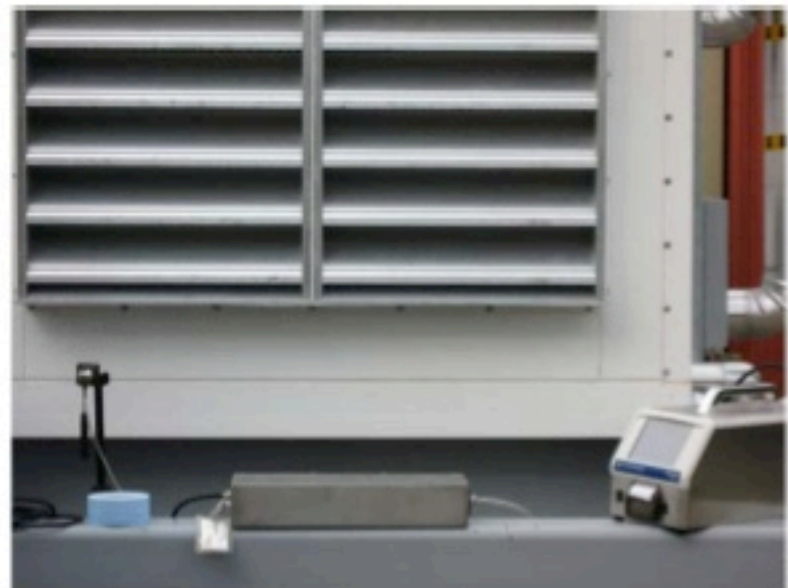
View of probe on tripod,
diluter and Laser Particle
Counter used during data
acquisition

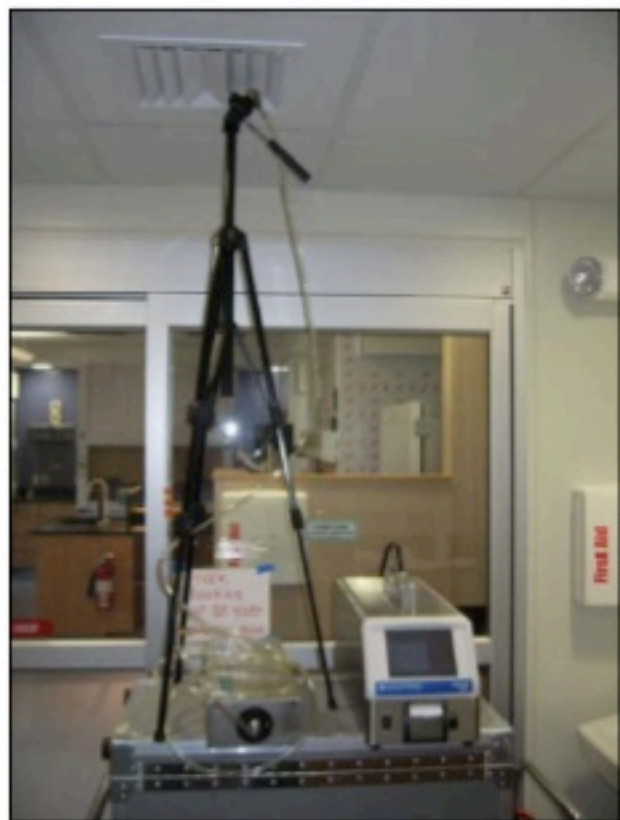
Lab "airlock" supply diffuser outlet test location #1

Lab#1 Supply outlet diffuser

Sample	Date	Time	Particle Sizes Micrometers							
			0.1	0.15	0.2	0.25	0.3	0.5	1	5
1	6/19/2008	8:41:07	33176	16275	7179	1590	919	65	25	2
2	6/19/2008	8:42:19	33690	17104	7462	1693	968	44	13	1
3	6/19/2008	8:43:32	33628	17009	7567	1632	947	32	9	0
4	6/19/2008	8:45:10	34178	17345	7603	1689	1009	44	8	1
5	6/19/2008	8:46:39	34281	17401	7556	1661	945	22	3	1
6	6/19/2008	8:47:54	34167	17399	7623	1674	1001	34	7	2
Average Count			33853	17089	7498	1657	965	40	11	1
Normalized 100:1 dilution count			3385333	1708883	749833	165650	96483	4017	1083	117
Removal Efficiency			70.6%	79.4%	82.7%	88.0%	89.0%	89.9%	78.6%	-7.7%

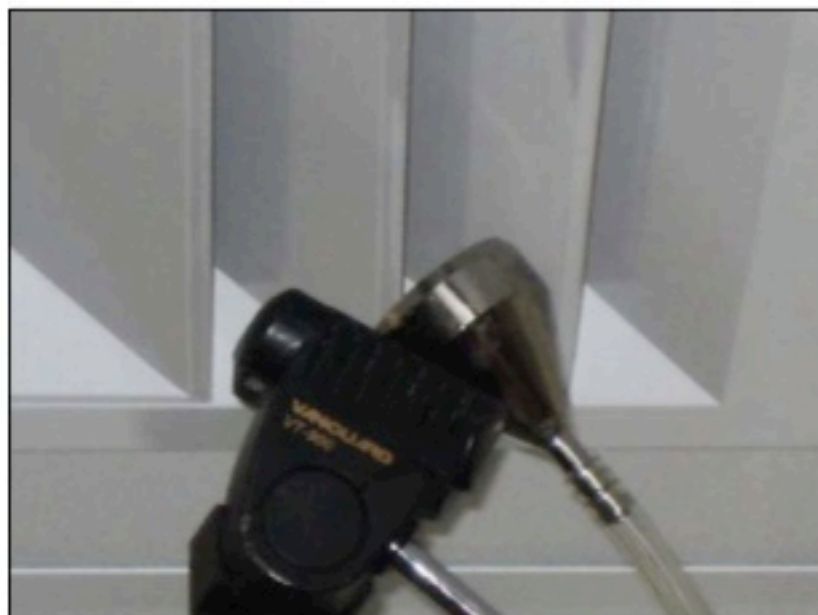
Close up of location #1

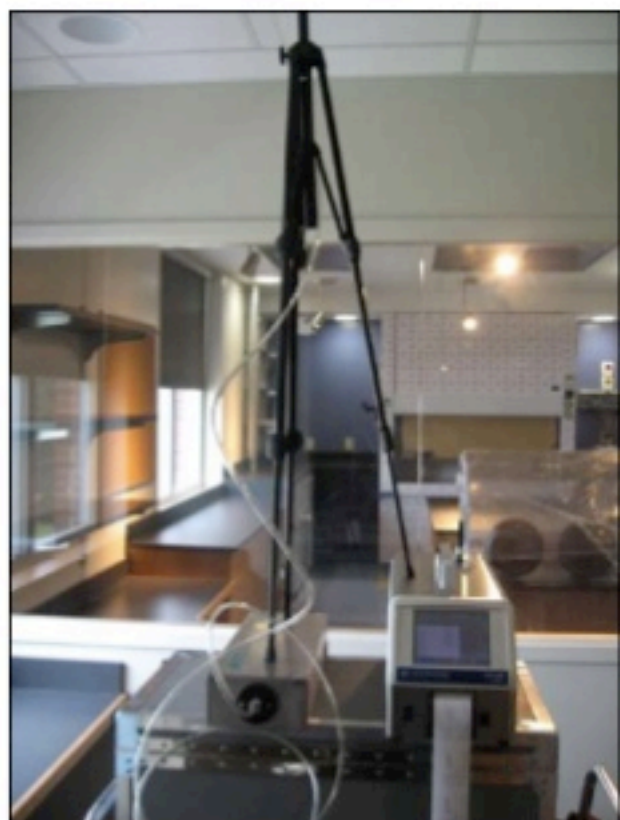
Lab "write up area" supply diffuser outlet test location #2

Lab/Office#2 Supply outlet diffuser

Sample	Date	Time	Particle Sizes Micrometers							
			0.1	0.15	0.2	0.25	0.3	0.5	1	5
1	6/19/2008	8:54:33	37821	20510	9712	2369	1409	68	22	1
2	6/19/2008	8:56:06	37615	20904	10045	2540	1509	139	66	2
3	6/19/2008	8:57:19	37620	20777	9954	2516	1553	139	56	6
4	6/19/2008	8:58:32	38168	21290	10329	2641	1648	172	93	6
5	6/19/2008	8:59:46	38180	21144	10308	2759	1721	209	100	7
6	6/19/2008	9:01:03	38280	21164	10495	2853	1767	220	114	7
Average Count			37947	20965	10141	2613	1601	158	75	5
Normalized 100:1 dilution count			3794733	2096483	1014050	261300	160117	15783	7517	483
Removal Efficiency			67.0%	74.7%	76.6%	81.1%	81.7%	60.5%	-48.6%	-346.2%

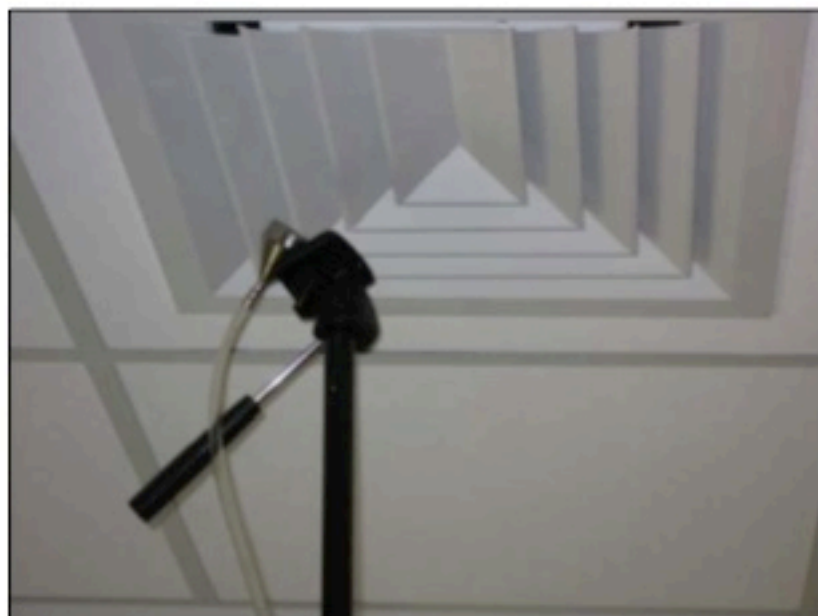
Close up of location #2
