Clyde River Landslide

Department of Geology, Perkins Hall, University of Vermont, Burlington, VT 05405

Abstract:

Jason Scott
Jason Bedard
Greg Van Gilder

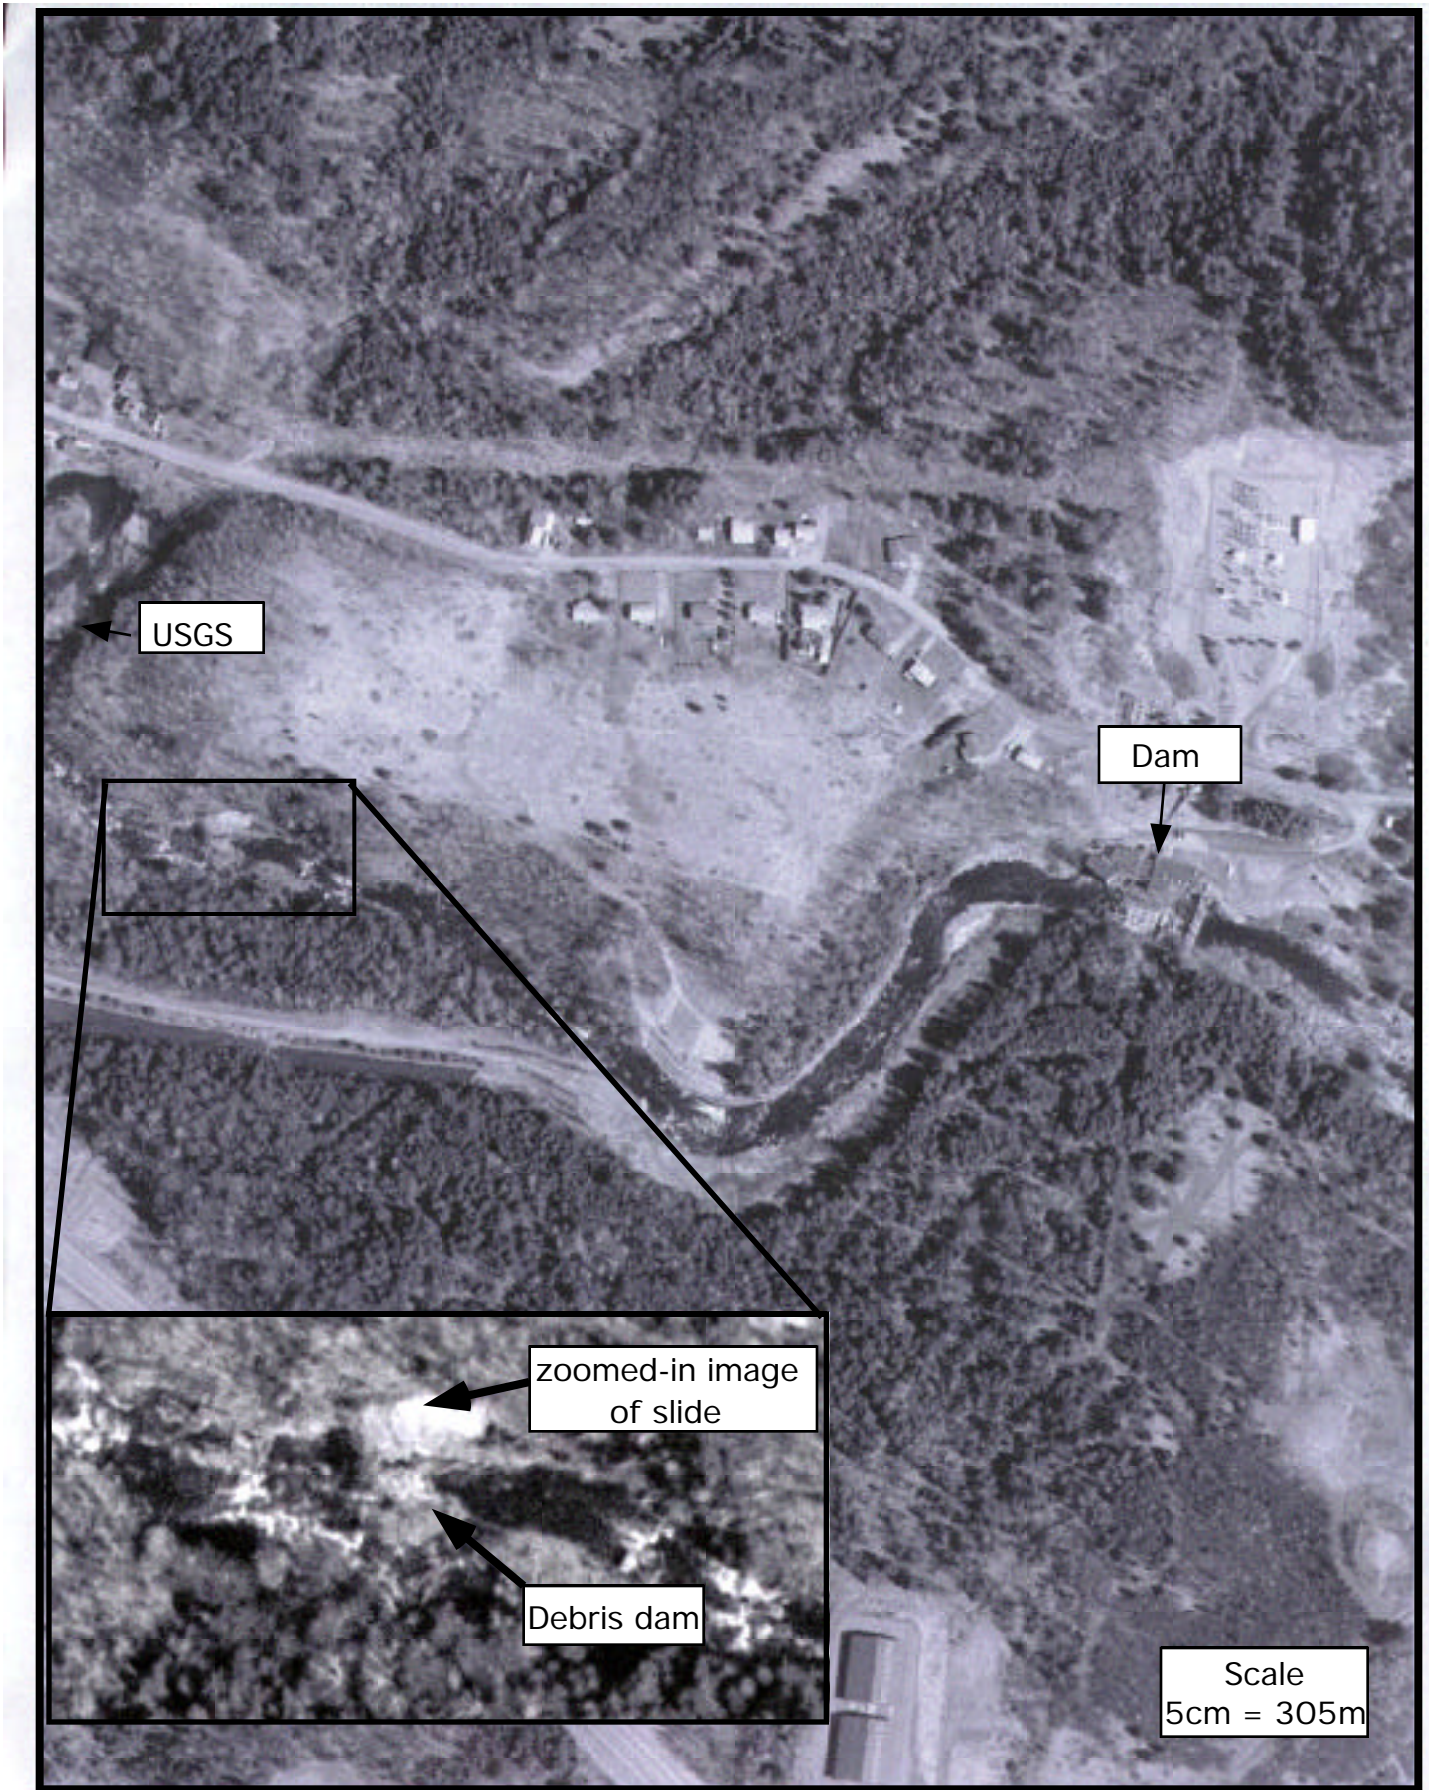
the top of the slide. Airphotos helped to determine the history of the slide. The 1963 and 1975 paper orthophotos showed that sliding had been taking place in the past (see figures 3 and 4). The 1987 printed photograph again revealed evidence of slope failure in the area of the slide studied. In the 1999 orthophotos the sliding was visible as well (see figure 2). Animal burrows were photographed (see figure 15), along with vegetation on the slide (see figure 14). Other observations include landslide scars next to the slide studied, along with river flow along the cut bank and the presence of undercutting. We also noted the stability of the layers. The clay and silt rhythmites were broken into two sections the upper redder section that yielded a strength around 1 and the lower grayier section yielded a strength around 2. The sand and silt rhythmites were visibly the weakest layer but could not be measured. Large cracks were visible that were easily pulled off the slide. Deposits on the sand and silt layer in the form of mud drippings down the 5 meter till deposit layer were visible. Also observed was the failed material forming an island in the middle of the Clyde River at the base of the landslide that helped to form a dam consisting of large woody debris (see figure 6).

Figure 2: This aerial photograph was taken in 1999.
